# James DeYoung Plant - Coal Yard and Ash Pond Detection Monitoring & Status of Closure Documentation

Holland Board of Public Works  
Holland, Michigan

NTH Project No. 73-160017  
May 28, 2019

NTH Consultants, Ltd.  
608 S. Washington Avenue  
Lansing, MI 48933

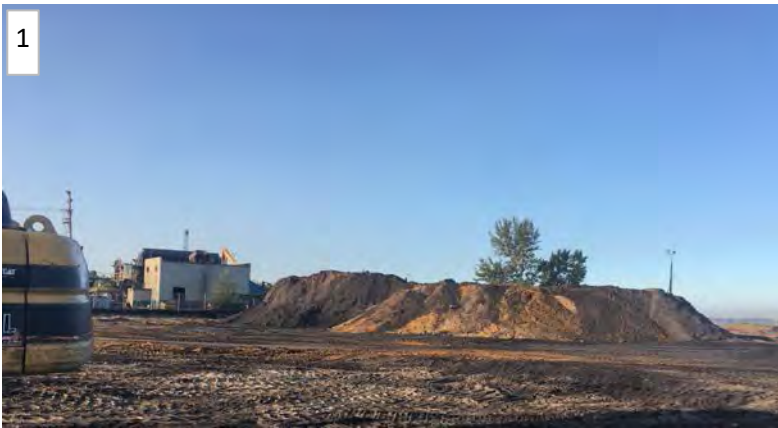
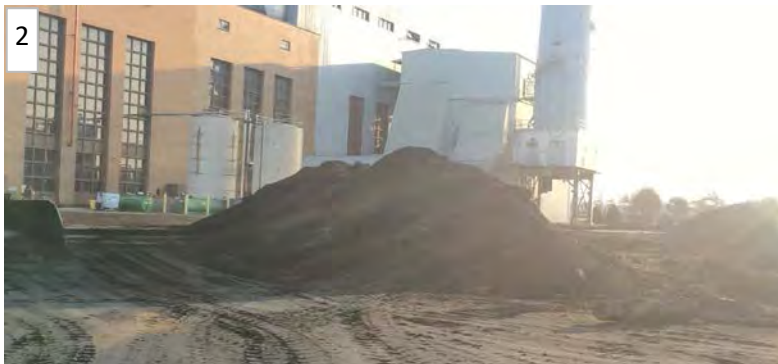
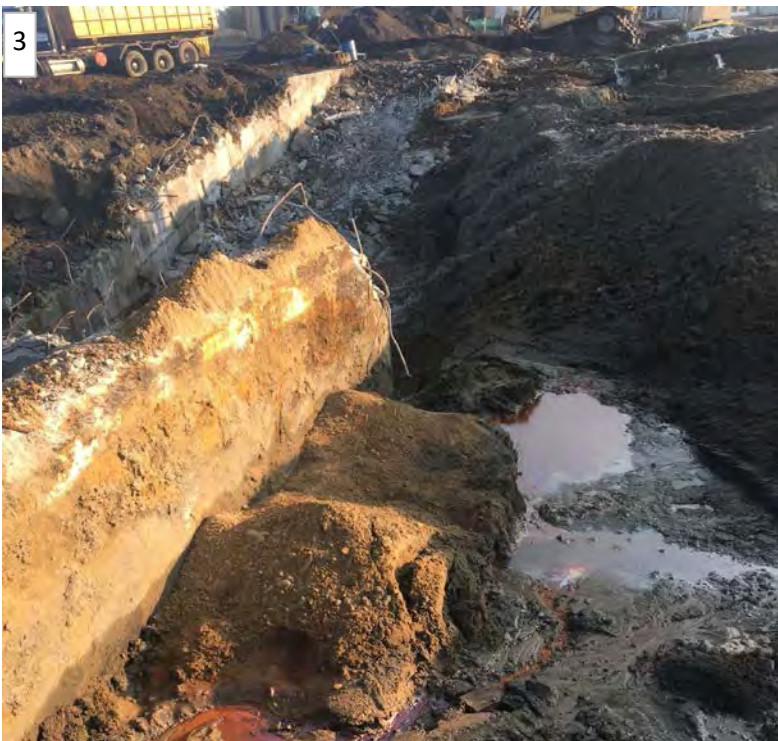
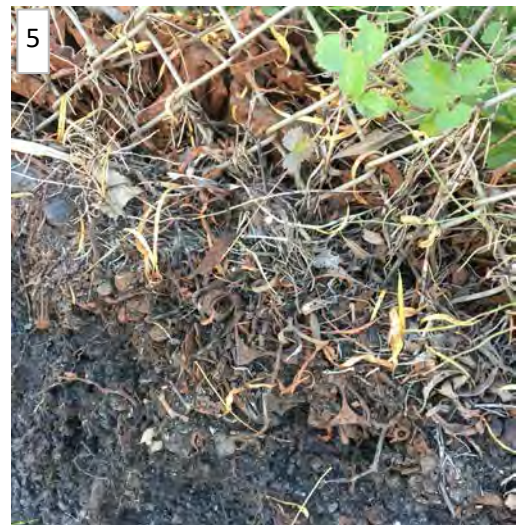
Date: 9/15/2017

- 1. CCR Pile on south end
- 2. CCR Pile on north end
- 3. Sand placed over concrete on pipe patch
- 4. Fence line soil profile, south fence
- 5. auto fluff found along south fence

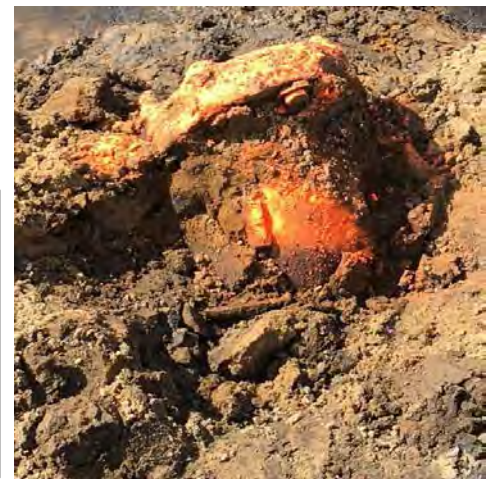
4

1. Sand starting to be filled in hopper hole, previously filled with flowable fill.
2. Drain pipe from plant found, looking south near conveyor area
3. Concrete manhole found, near pipe
4. Another piece found for removal, near manhole and pipe

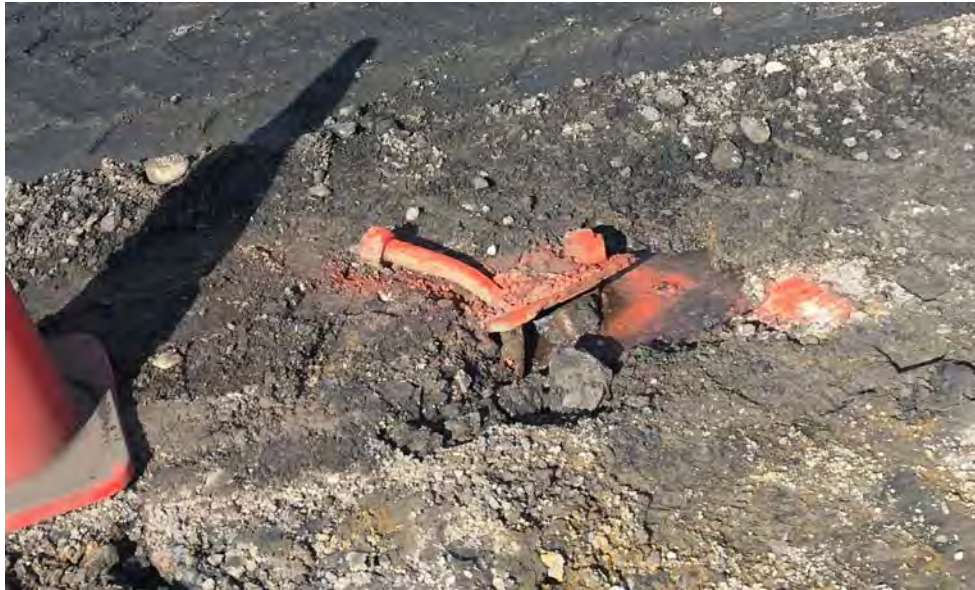
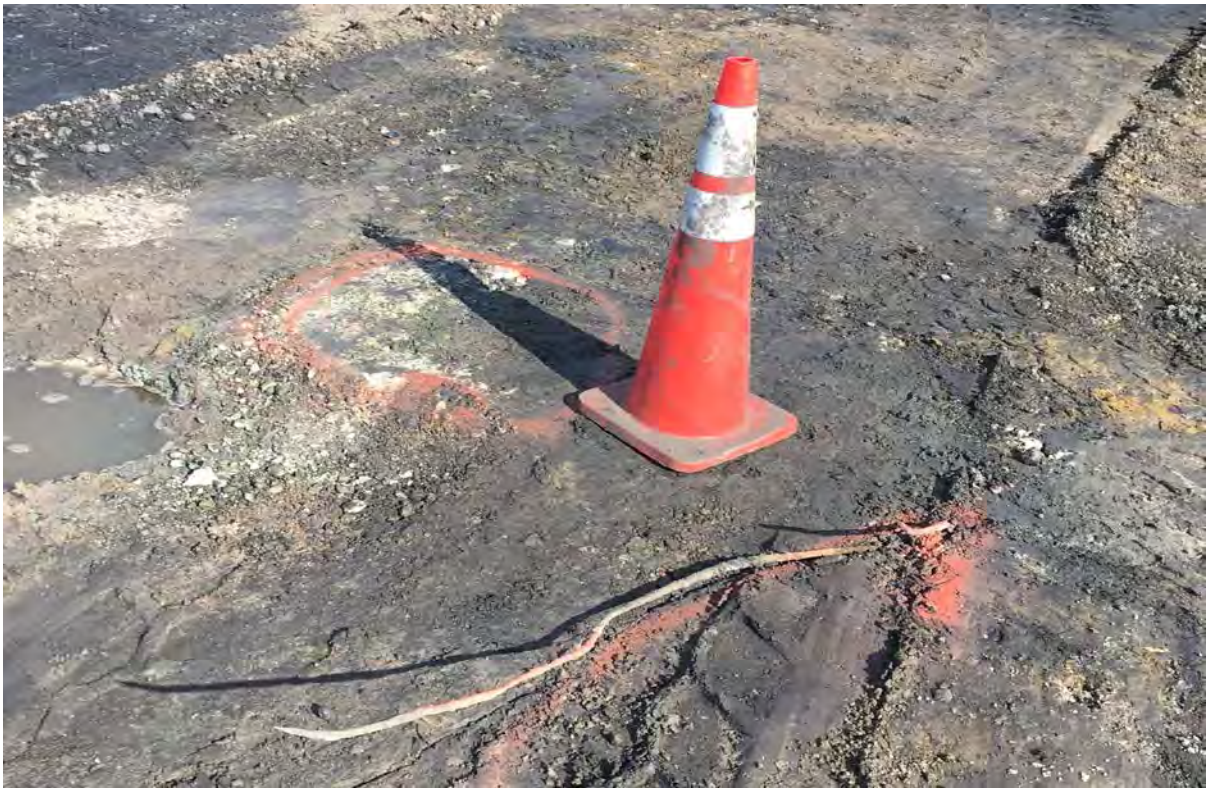
Date: 9/28/2017

pieces found in soil for removal near center of site

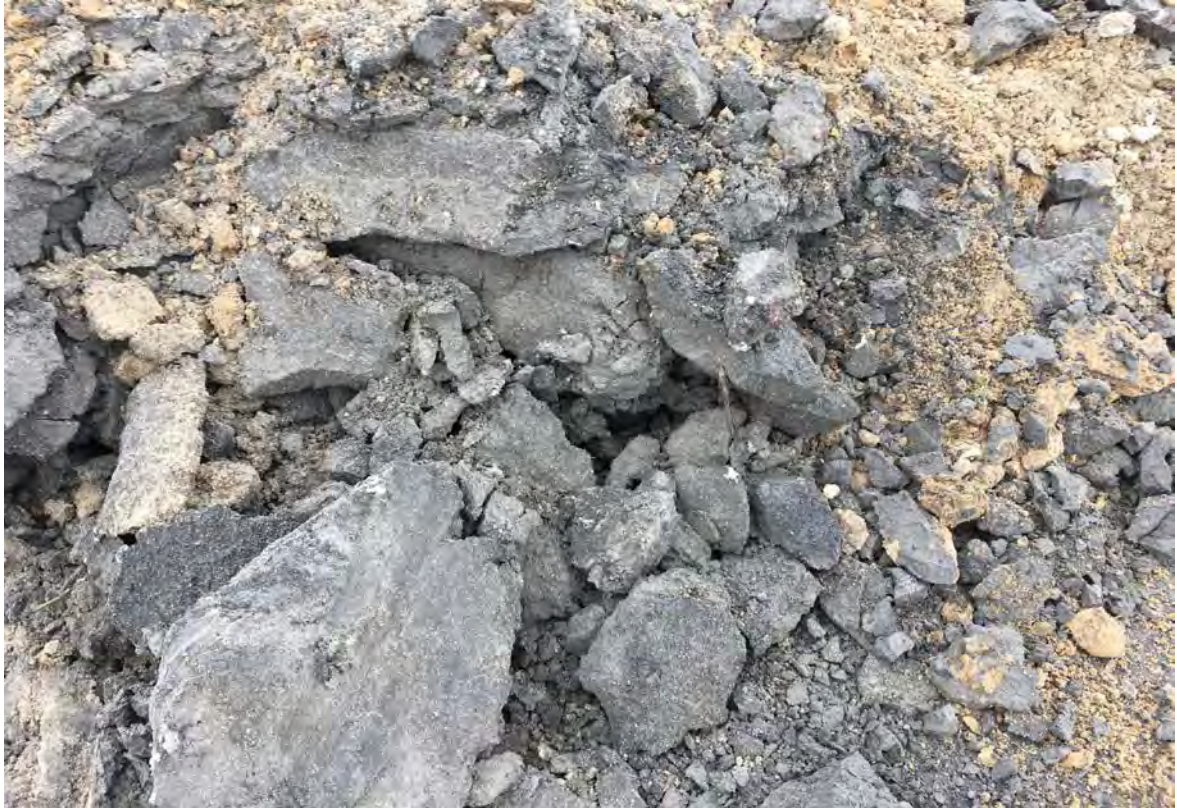
Date: 10/4/2017

Ash found near slag pit to be removed

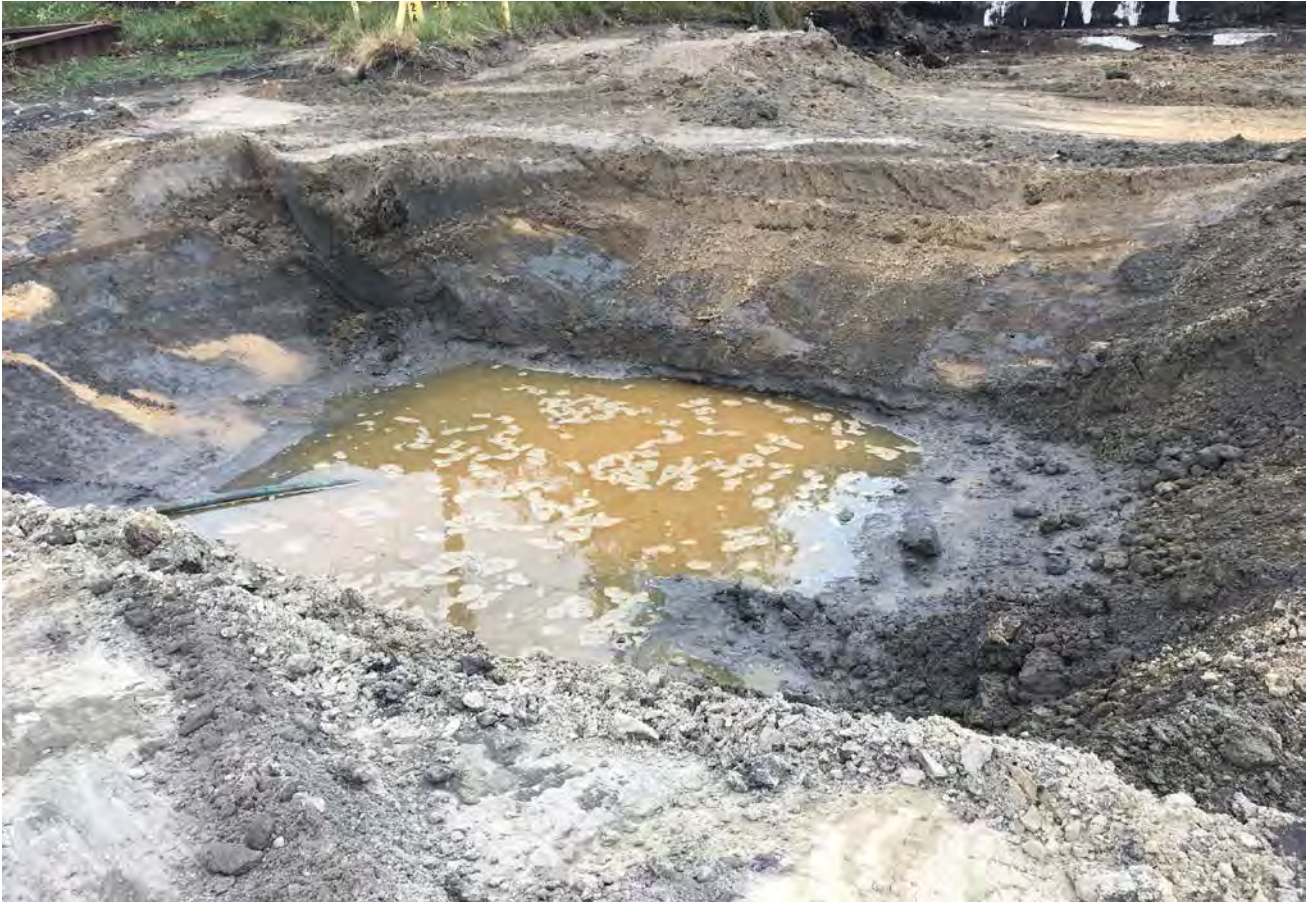
Date: 10/10/2017

Area near south fence found to have CCR material and excavated

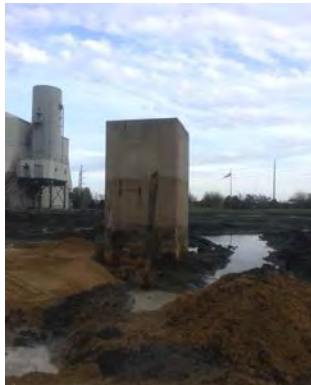
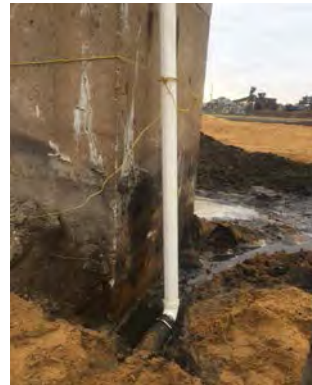
Teeing of leaking storm sewer pipe at the northwest corner of the storm junction box

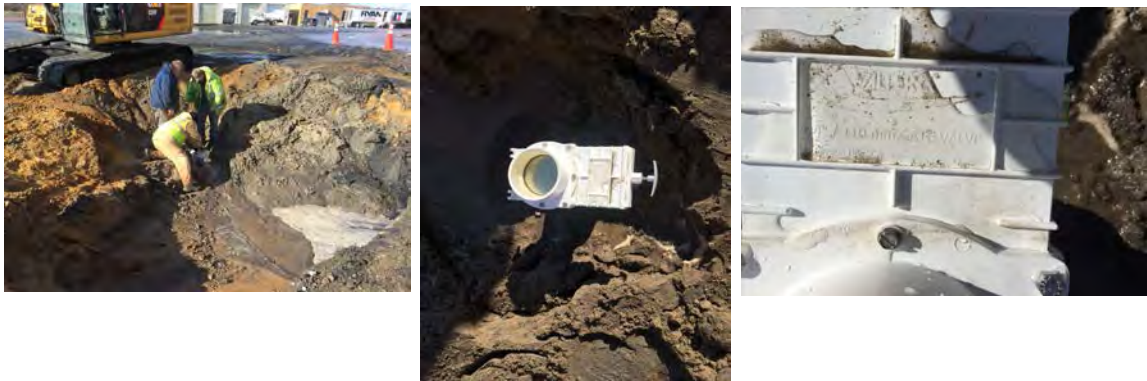
Gate Valve being placed on leaking storm pipe just east of the large concrete pad

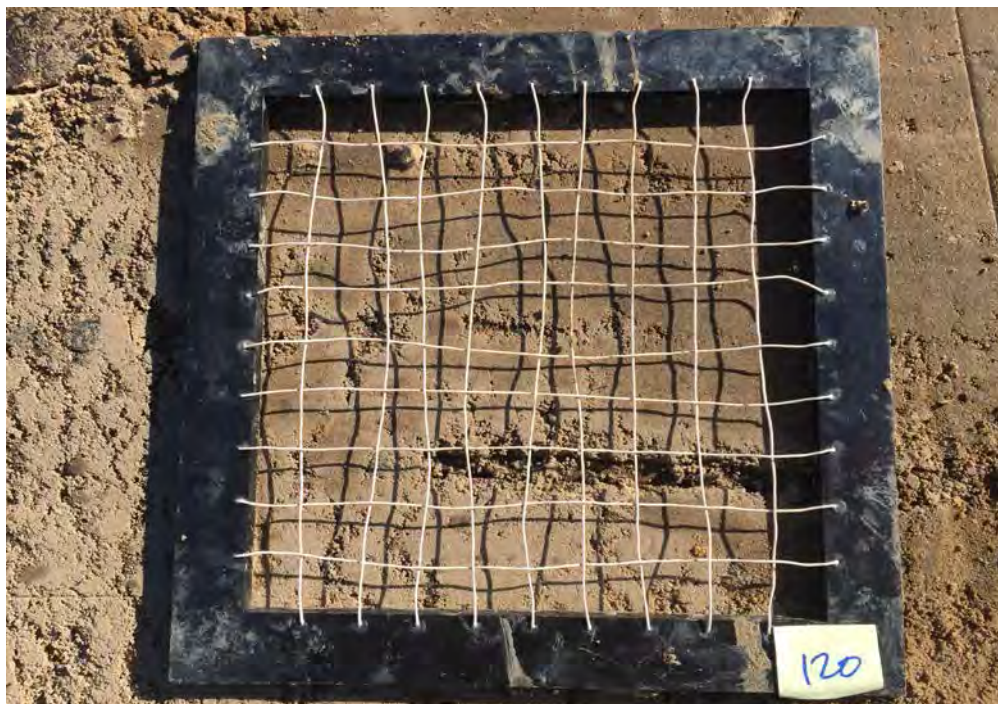
Light brown silty fine sand with trace gravel

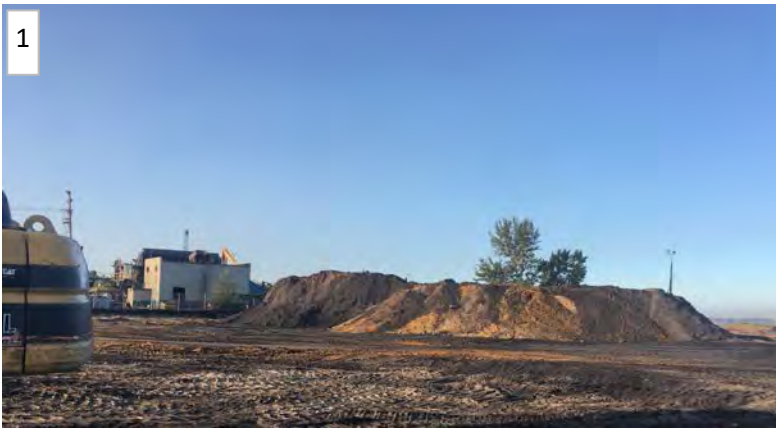
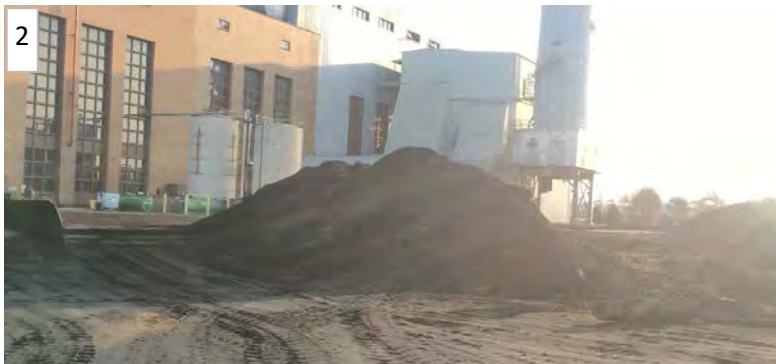
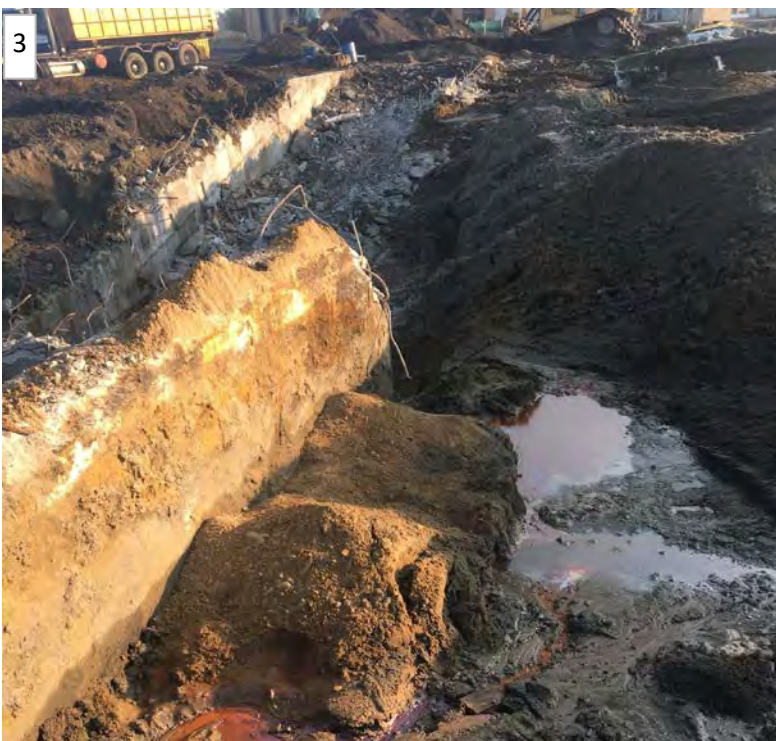
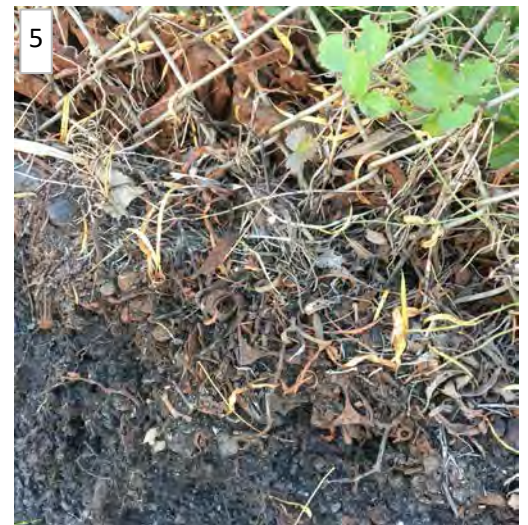
Date: 9/15/2017

- 1. CCR Pile on south end
- 2. CCR Pile on north end
- 3. Sand placed over concrete on pipe patch
- 4. Fence line soil profile, south fence
- 5. auto fluff found along south fence

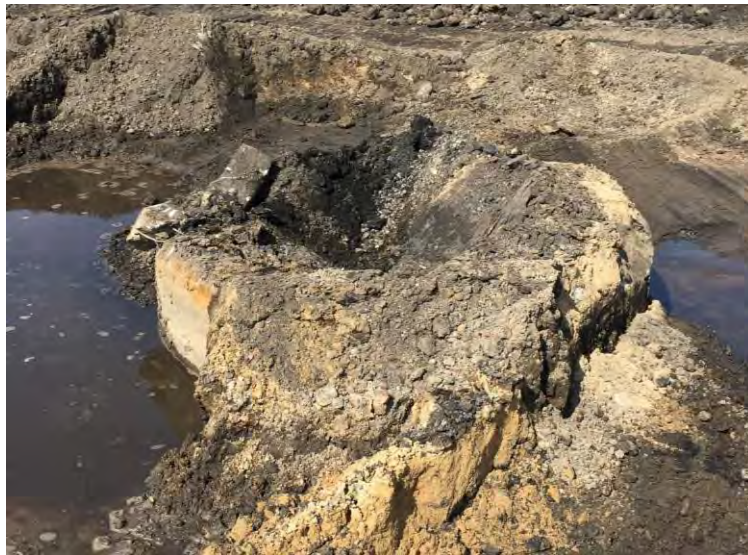
3

1. Sand being filled in hopper hole, previously filled with flowable fill.
2. Drain pipe from plant found, looking south near conveyor area
3. Concrete manhole found, near drain.

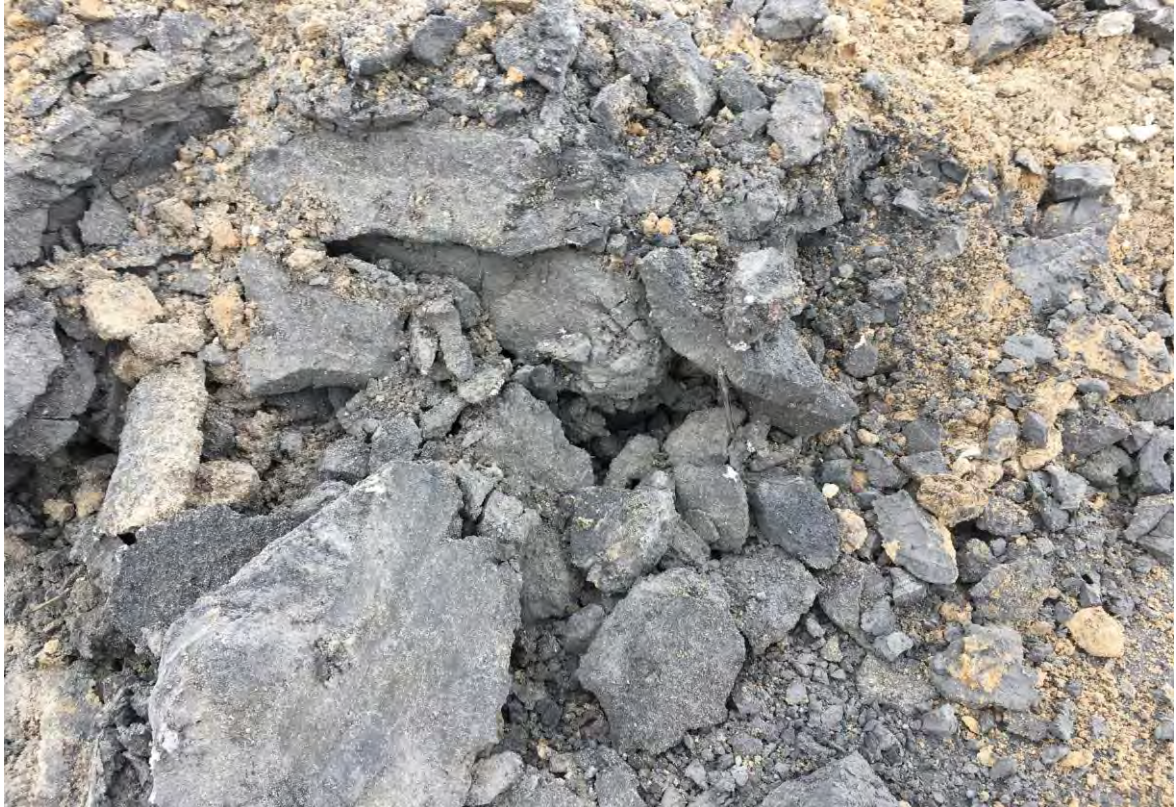
10/4/2017

Ash found near Point 196 to be removed

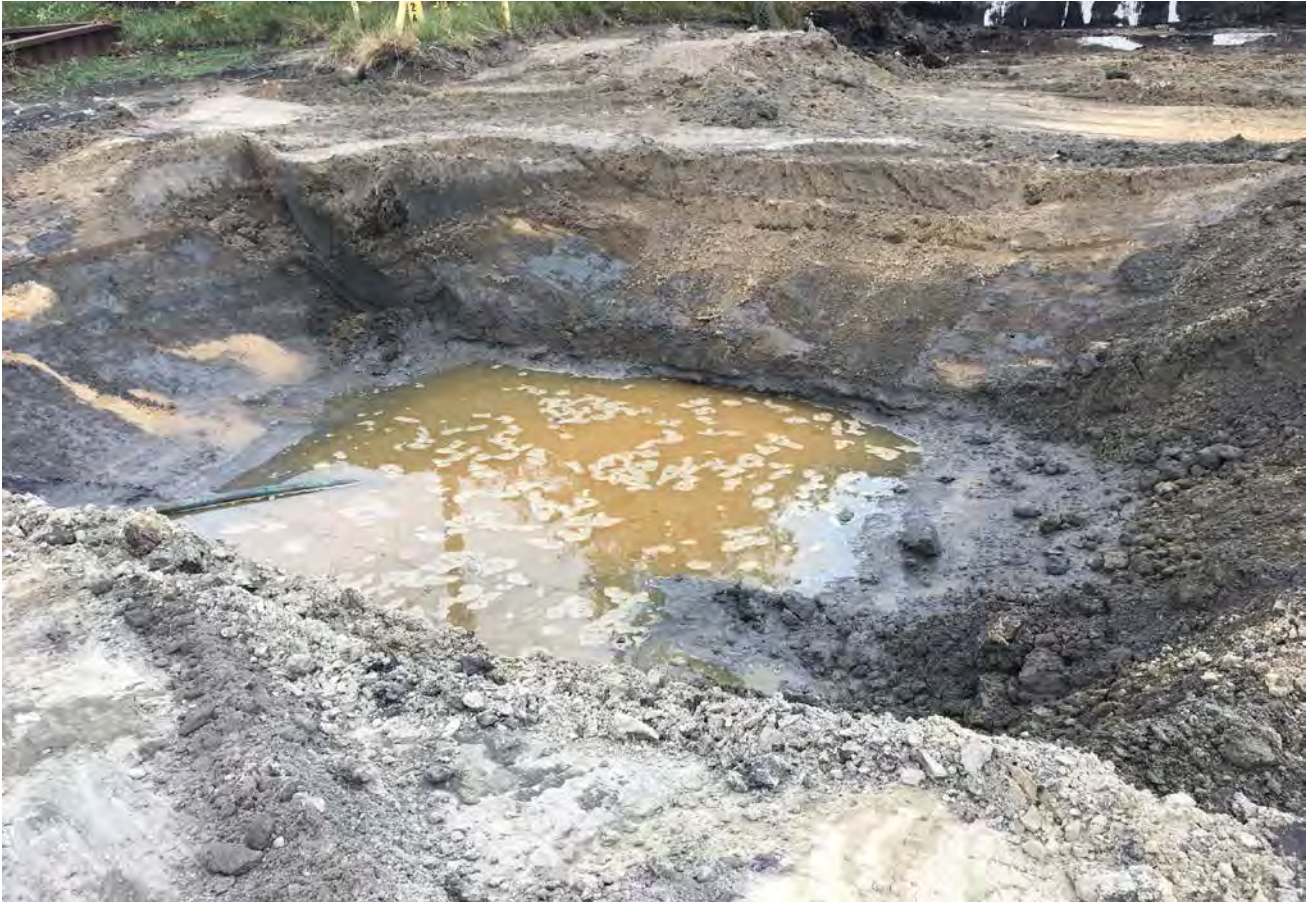
Date: 10/10/2017

Area near south fence found to have CCR material and excavated

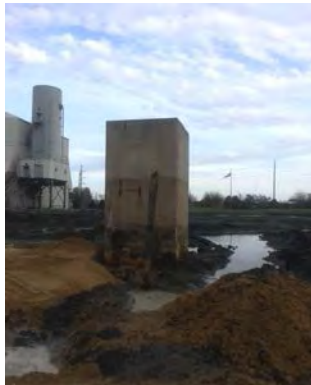
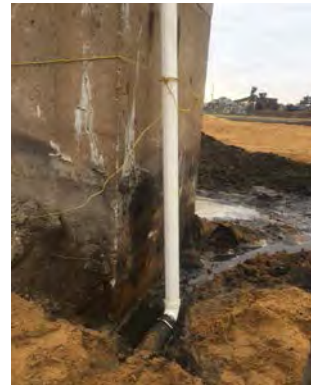
Teeing of leaking storm sewer pipe at the northwest corner of the storm junction box

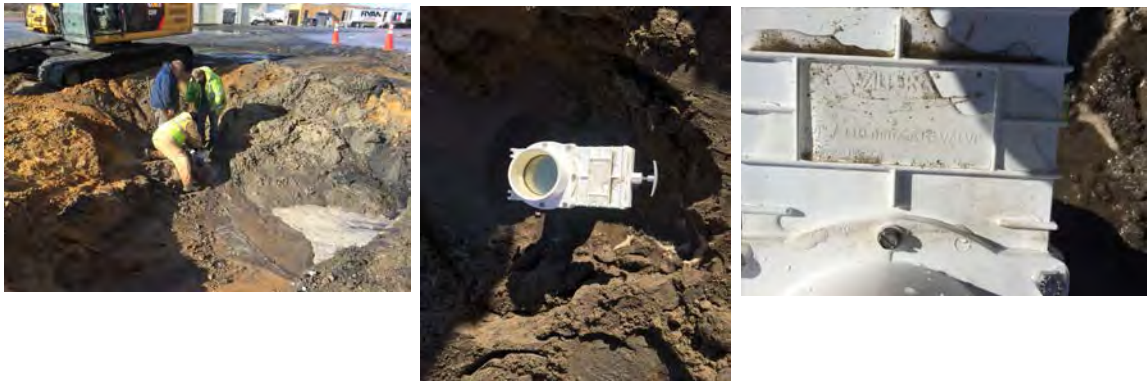
Gate Valve being placed on leaking storm pipe just east of the large concrete pad

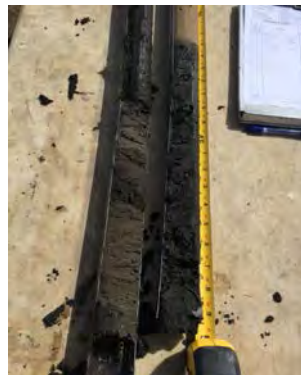
Picture of unnatural material found at point 196

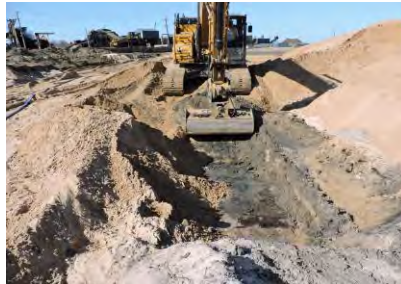
Excavating the CCR material found between Points 4081 and 4082

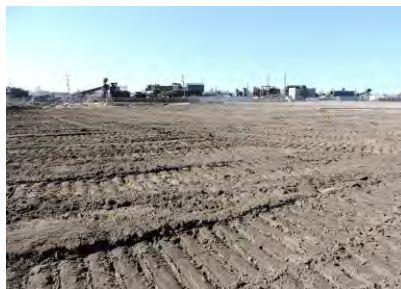
Topsoil along west edge of verified CCR area

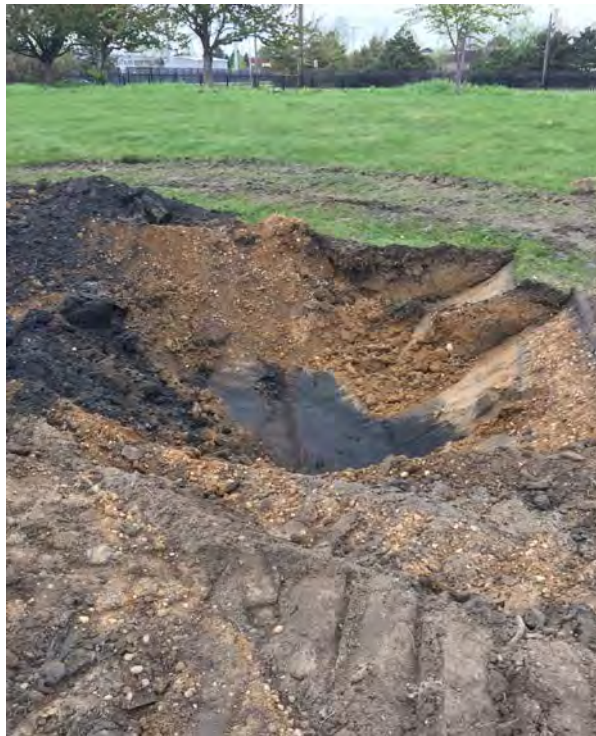
Ash found outside of limits

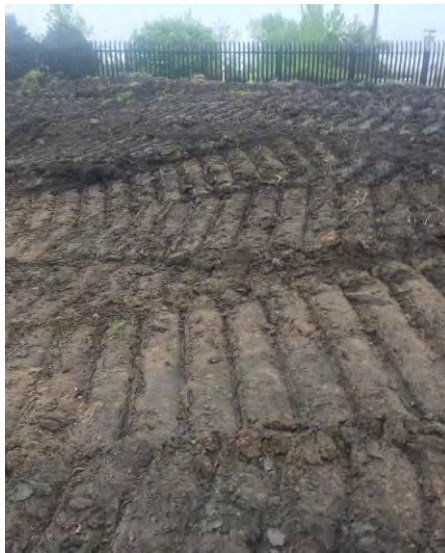
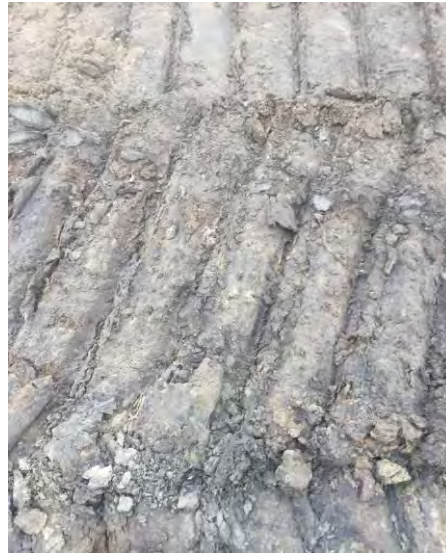
Materials observed via microscope at request of John.  
Both needed slightly more excavating.

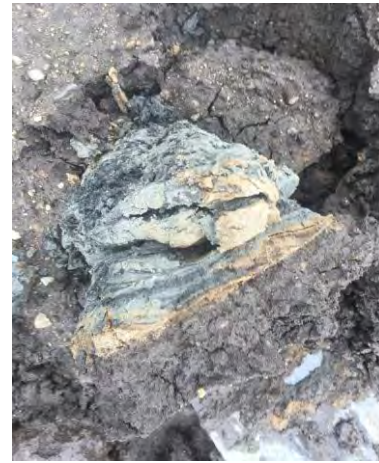
Natural material found at Points 246, 4146, and 4147 during soil depth measurements. Verified via microscope, that it is natural material.

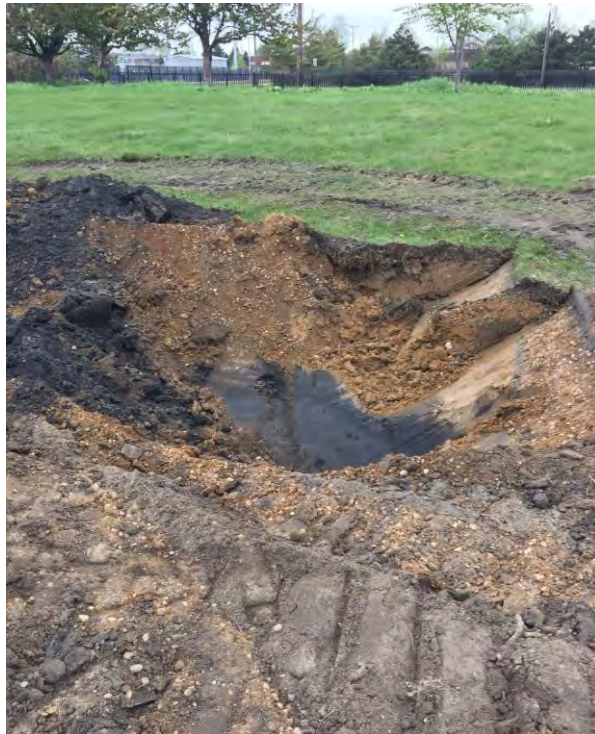
Ash found outside of limits

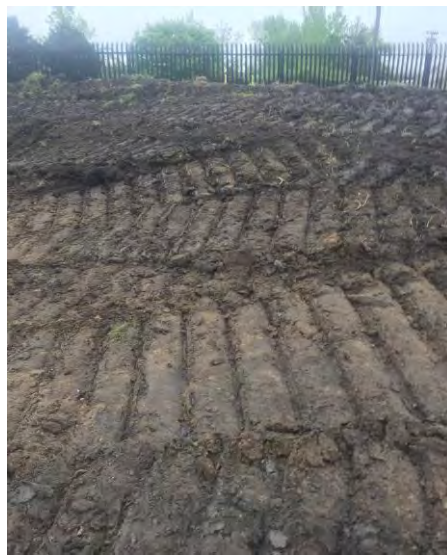
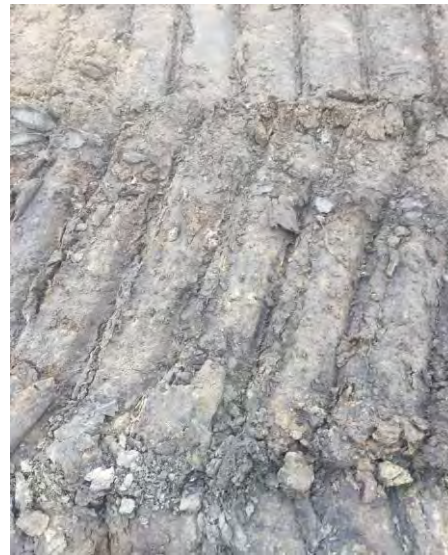
Materials observed via microscope at request of John.  
Both needed slightly more excavating.

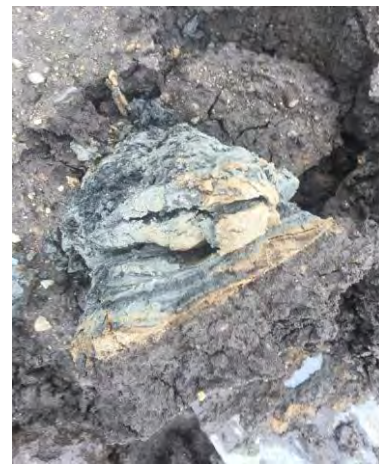
Natural material found at Points 246, 4146, and 4147 during soil depth measurements. Verified via microscope, that it is natural material.
